**Alkaline Copper Treated Wood for Residential Use**

University of British Columbia  
Professor John Ruddick

**Preservative mobility in decking**

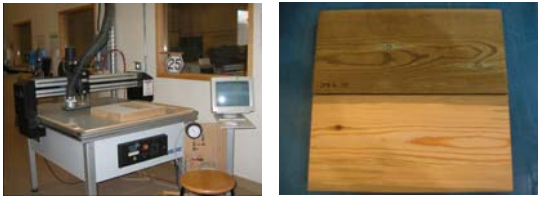
### Chemical analysis

- Treated surface of reference section removed using a computerised routing system
- Analysed by x-ray spectroscopy to provide reference retention
- Penetration of the copper determined for each surface, including end penetration

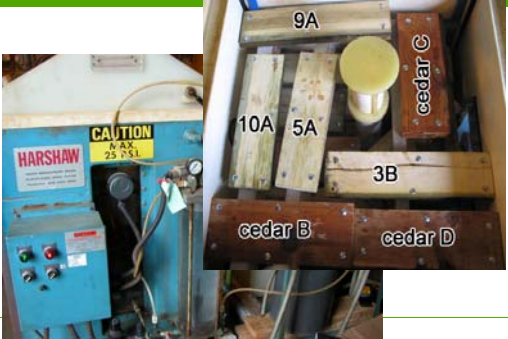
How do we test fasteners?

- ### Climate conditions
- Harshaw Environmental chamber  
0.7 x 0.76 x 1 m
  - Water temperature – 32 ° C
  - Water mist pressure – 10 Pa
  - No direct spraying of fastener heads
  - Continuous misting except during evaluation

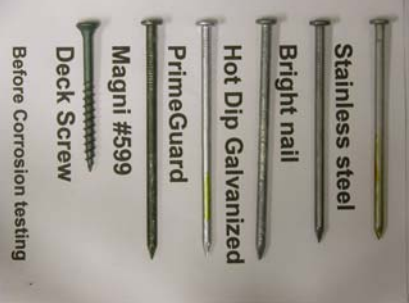
Fasteners before exposure

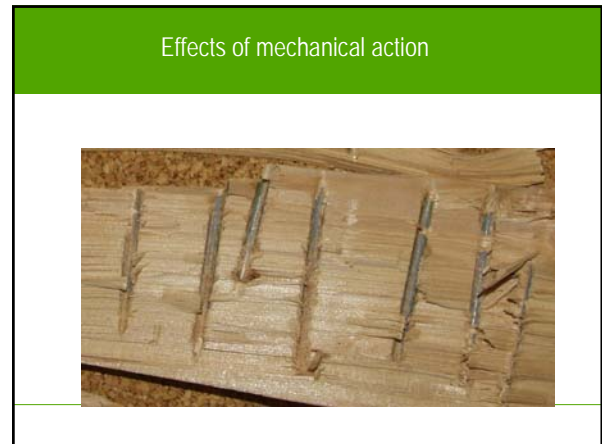
Nails hammered into wood and removed by carefully splitting wood

Nails weighed before placing in the sandwiched samples

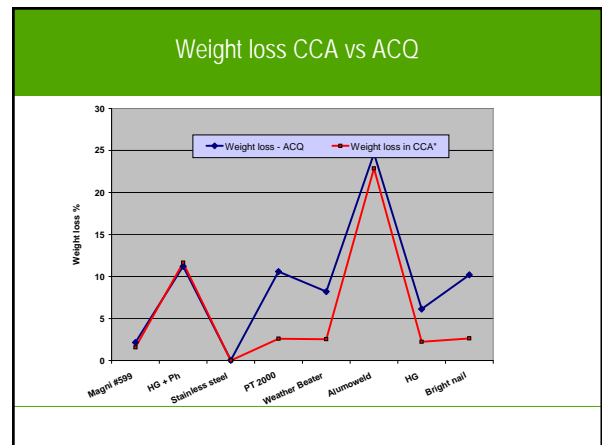
### Weight loss

- Weight Loss.
- Ultrasonic Bath used to clean the corrosion Products.
- Less accurate than diameter measurement due to difficulty of removing corrosion products.

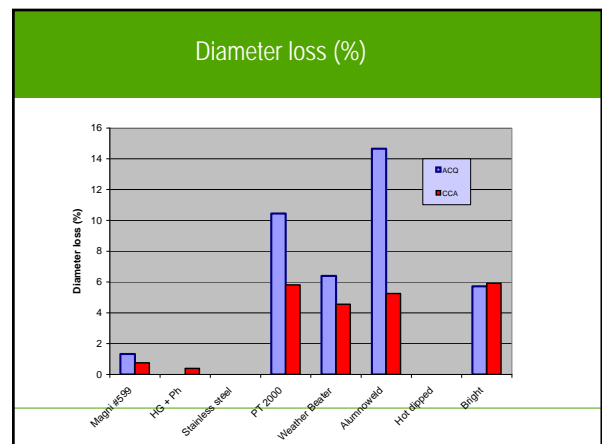
### Diameter loss (%)

- Diameter loss (Steel Core Cross-Section Reduction)
- Measured with Caliper to 0.0025 mm
- Can also be used to calculate cross sectional area loss
- Fails to assess pitting corrosion – pit depth

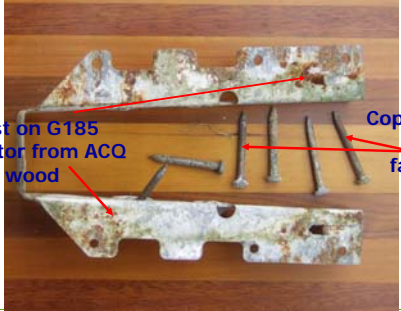
Red rust on G185 connector from ACQ treated wood  
Copper plated onto fasteners

- **Incorrect fasteners and connectors**
- **Incompletely fixed copper in alkaline copper treated wood**
- **Red rust formed on unprotected edges of G185 connectors**
  - Will this red rust lead to accelerated corrosion of galvanized face?
